Subject: Clean Water Act Compliance Evaluation Inspection Report

CWA COMPLIANCE EVALUATION INSPECTION REPORT
U.S. ENVIRONMENTAL PROTECTION AGENCY, REGION 5

Facility: Calamity Knoll

Date of Inspection: April 24, 2014

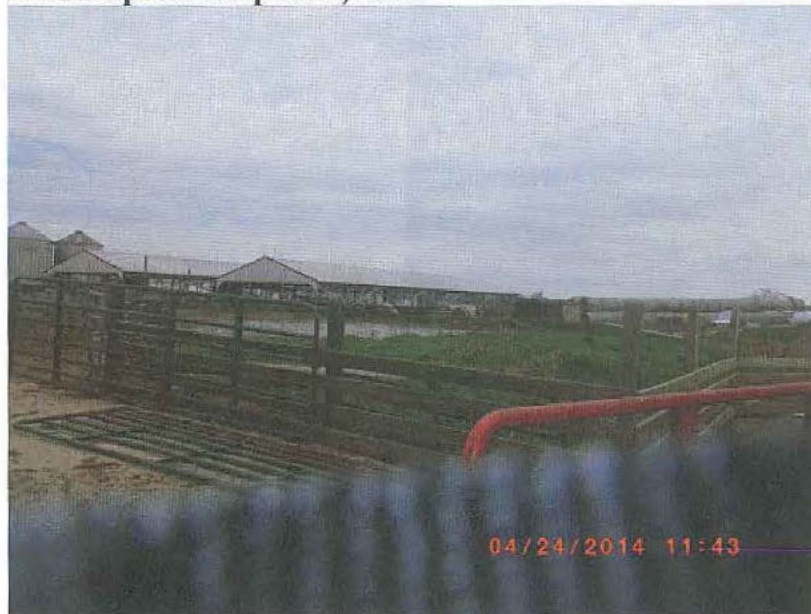
1: IMGP0627

Description: The Coughlin Pit, Hartgarten Barn and Cow Palace Barn can be seen in the background.

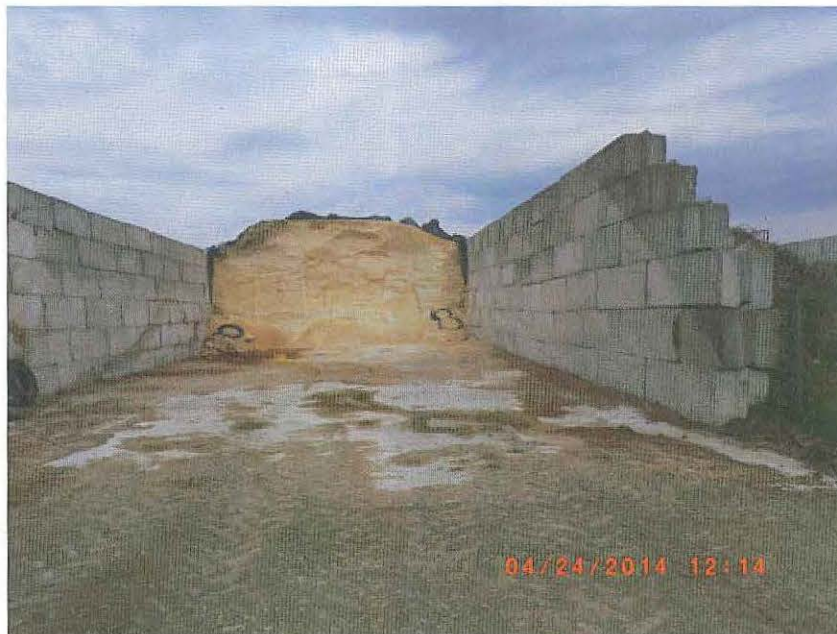
38: IMGP0664

Description: The feed bunker stored corn.

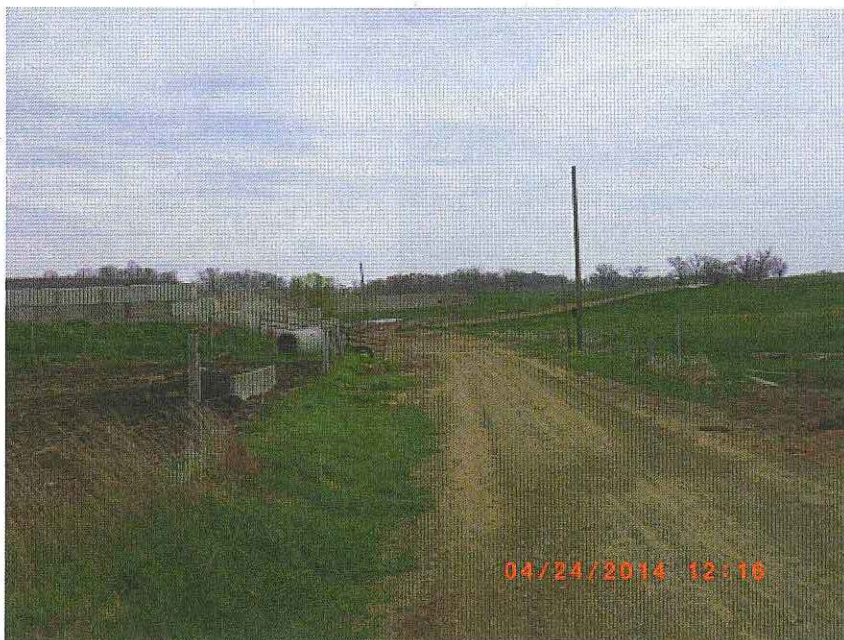
43: IMGP0669

Description: Access way with East lot on the left.

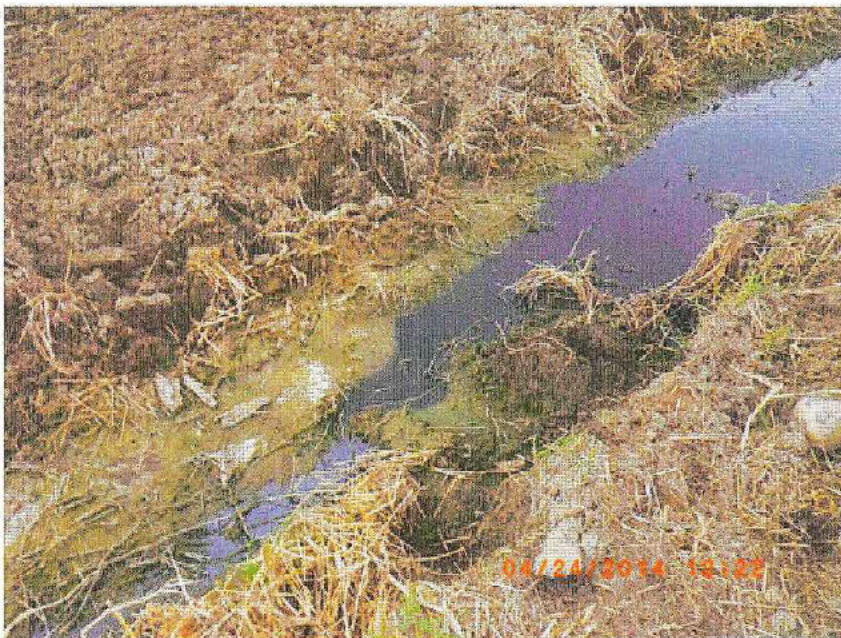
55: IMGP0681

Description: Water in the pathway was black and smelled like manure.

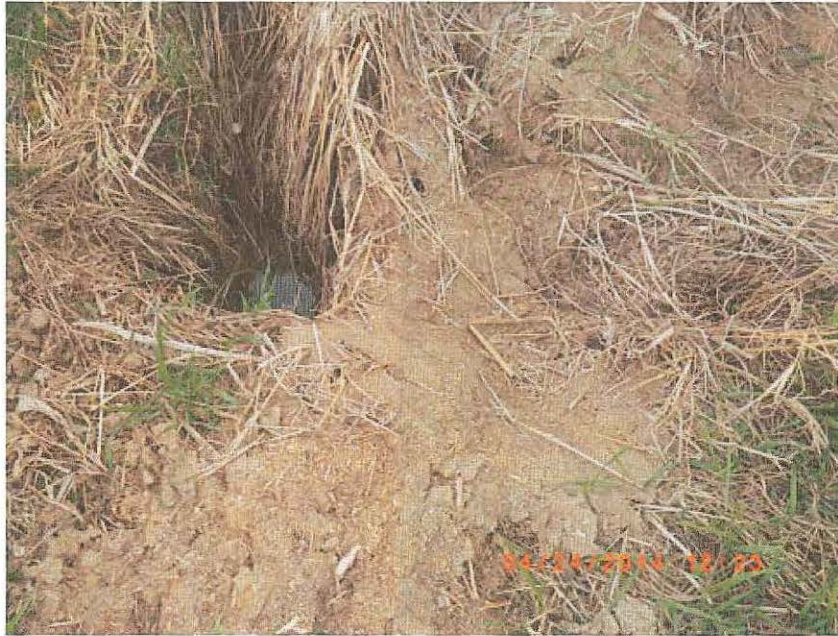
57: IMGP0683

Description: The water at inlet of culvert that drained under the access road to the south was black and smelled like manure.

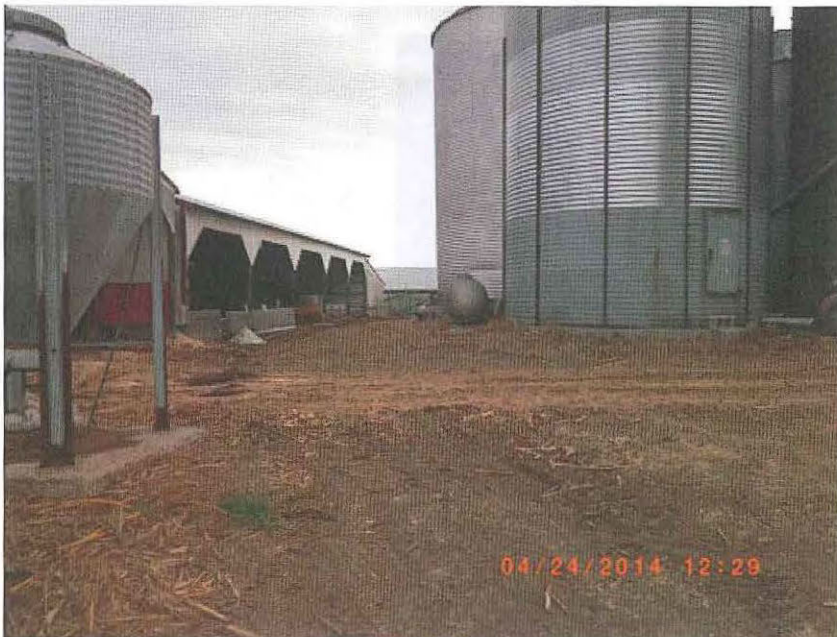
62: IMGP0688

Description: Access way south of North Shed.

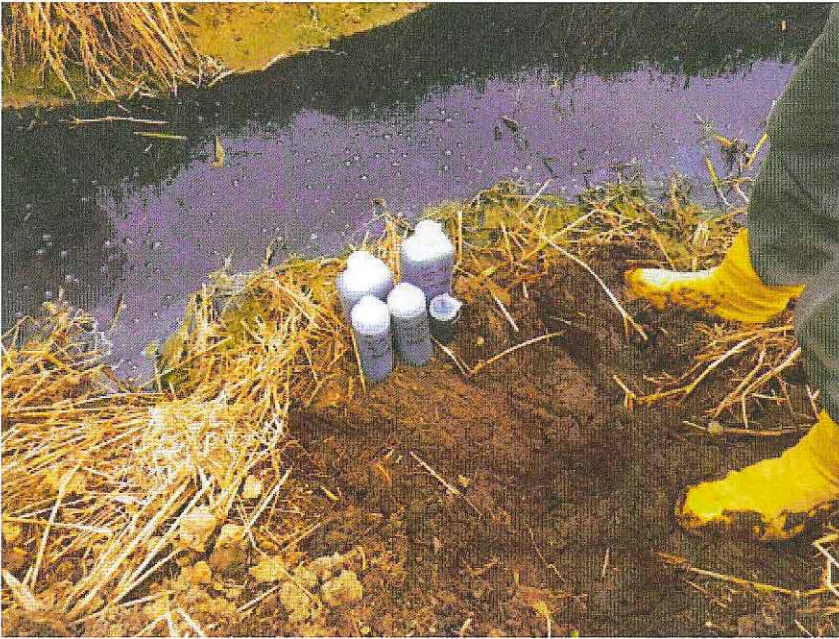
63: IMGP0689

A field blank was taken at 1:00 p.m. Sample S01 was taken at 1:15 p.m. of manure/process wastewater in the drainage pathway south of the East Lot (Attachment 2: IMGP0689; IMGP0690). Sample S02 was taken at 1:25 p.m. of water in gulley northeast of the feed bunkers (Attachment 2: IMGP0691; IMGP0692). Sample S03 was taken at 1:40 p.m. of process wastewater from the underground tank that accepts drainage from the Feed Bunkers (Attachment 2: IMGP0395; IMGP0696). Sampling concluded at 1:45 p.m. I took all samples. Samples were preserved according to EPA Region 5 Field Sampling Plan. Sampling locations can be seen in Attachment 1: Figure 2. We left the facility at 2:30 p.m.

Description: Sample S01 taken of water in drainage pathway. The water was dark and smelled of manure.

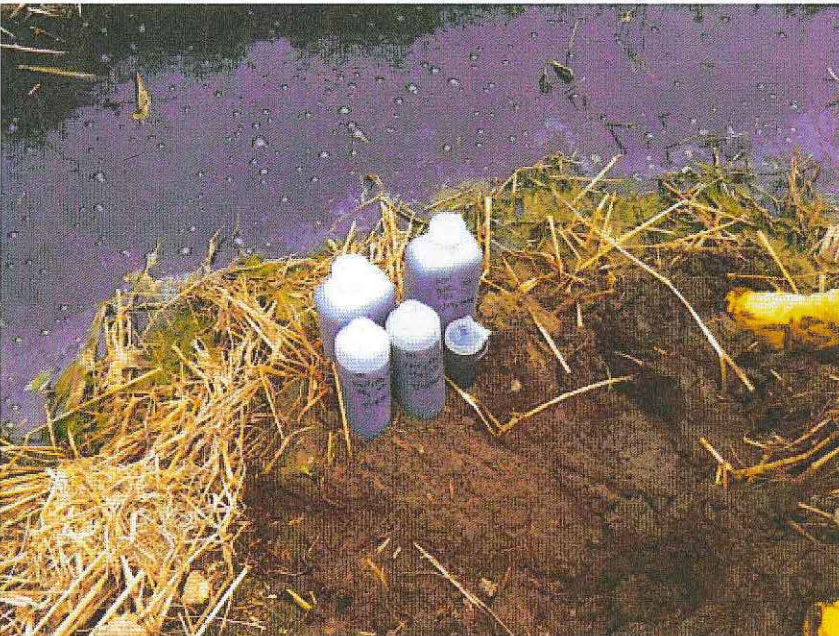
64: IMGP0690

Description: Sample S01 taken of water in drainage pathway. The water was dark and smelled of manure.

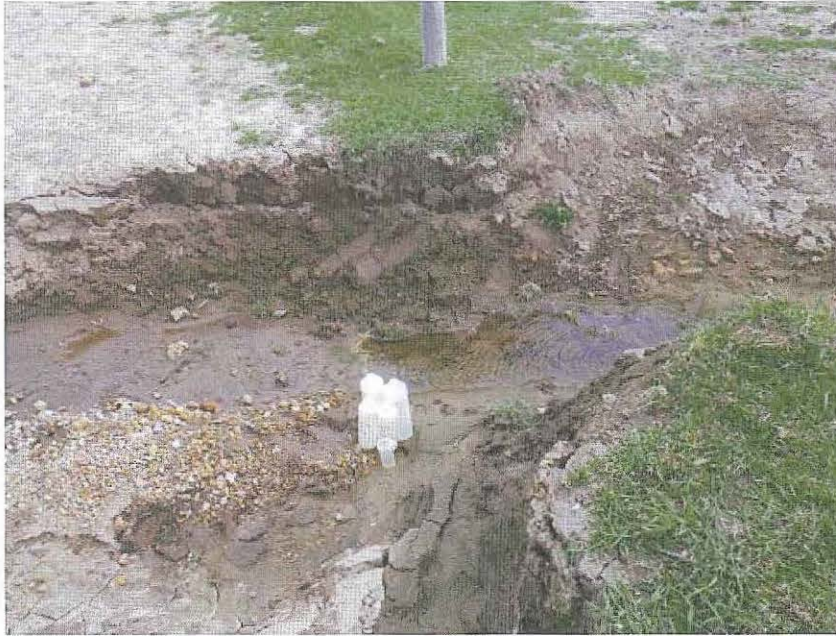
65: IMGP0691

Description: Sample S02 taken in gulley on north east end of the facility. The gulley is downstream of the drainage pathway.

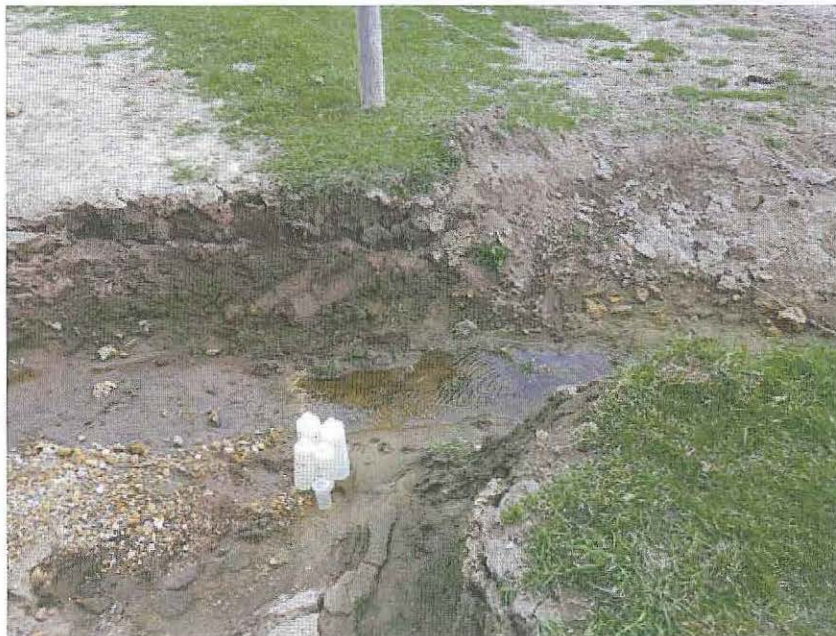
66: IMGP0692

Description: Sample S02 taken in gulley on north east end of the facility. The gulley is downstream of the drainage pathway.

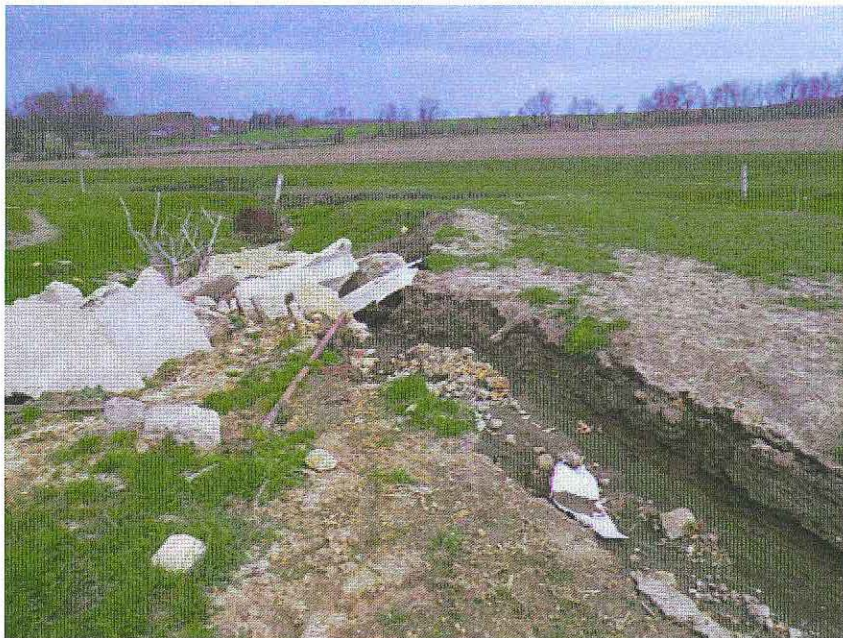
67: IMGP0693

Description: The gully drains to Spring Brook.

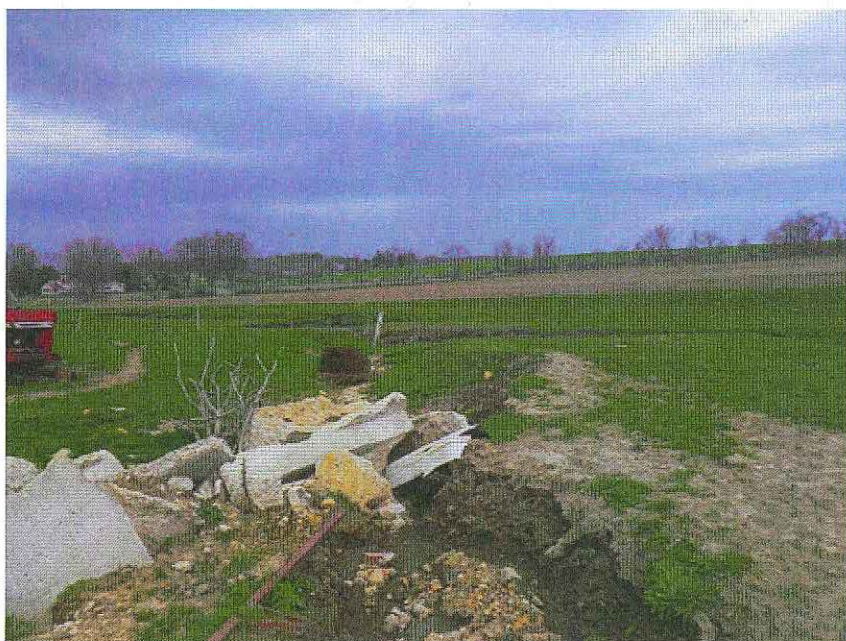
68: IMGP0694

Description: The gully drains to Spring Brook.

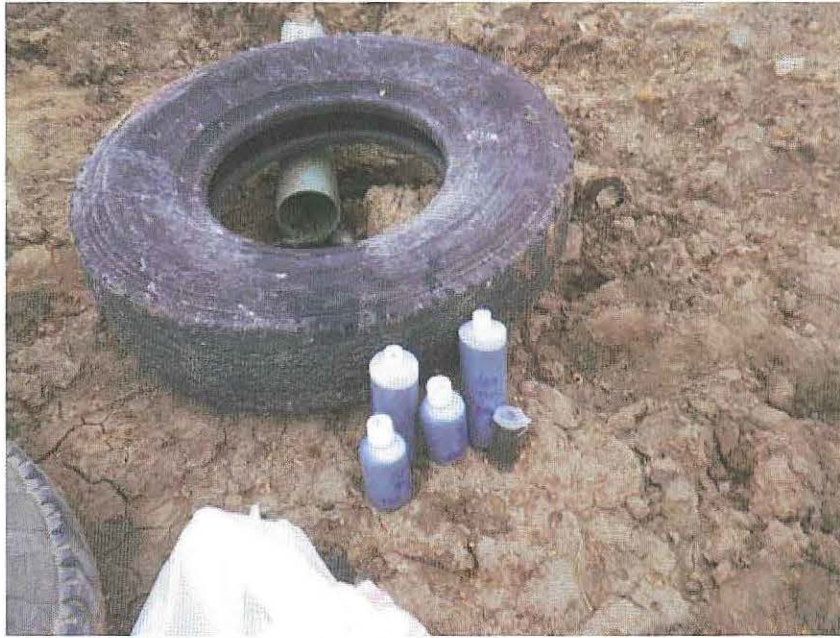
69: IMGP0695

Description: Sample S03 taken from underground tank that accepts drainage from the Feed Bunkers. The water was dark and smelled septic.

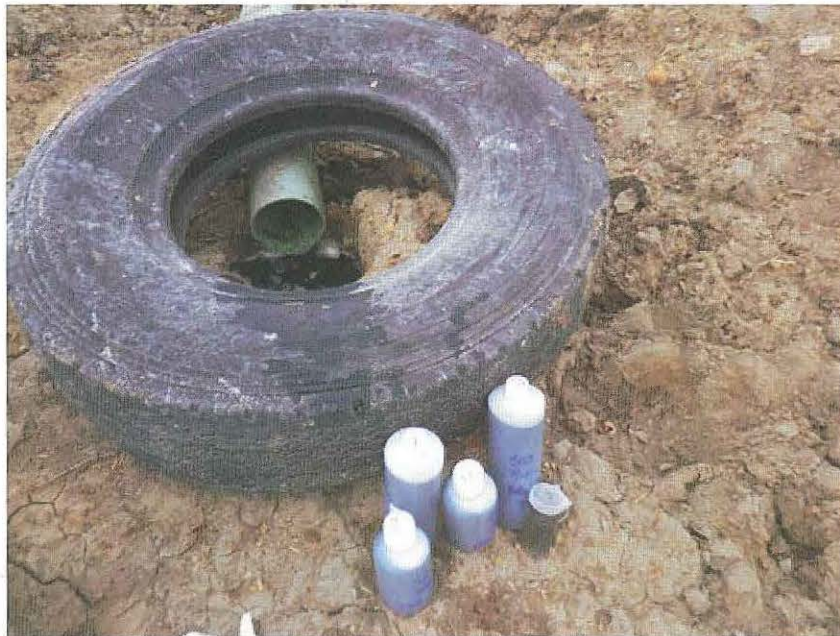
70: IMGP0696

Description: Sample S03 taken from underground tank that accepts drainage from the Feed Bunkers. The water was dark and smelled septic.
